**LEAD BASED PAINT  
INSPECTION  
REPORT**

Stevens Point Housing Authority  
1300 Briggs Court  
Stevens Point, WI 54481

Madison View Apartments  
WI037-008-70193  
Stevens Point, WI

Testing of this project was performed by Steve Plough of W.O., Ltd. (a division of schauer & associates, inc.) on January 3, through January 5, 1994. The instrument utilized to accomplish this testing was a Sitec Spectrum Analyzer.

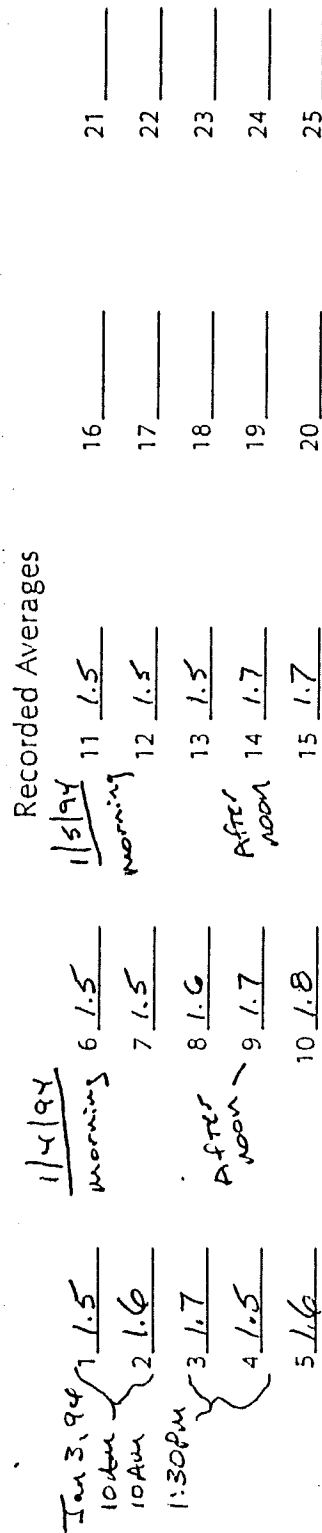
## Calibration Check Graph

All recorded numbers should be the average of five (5) "Test" runs or two (2) "Confirmation" measurements. Readings are to monitor system performance. All measurements must be taken in identical conditions. The position of the reference sample with respect to the scanner must be consistent.

SCANNER AND LEAD STANDARD  
SERIAL # 230

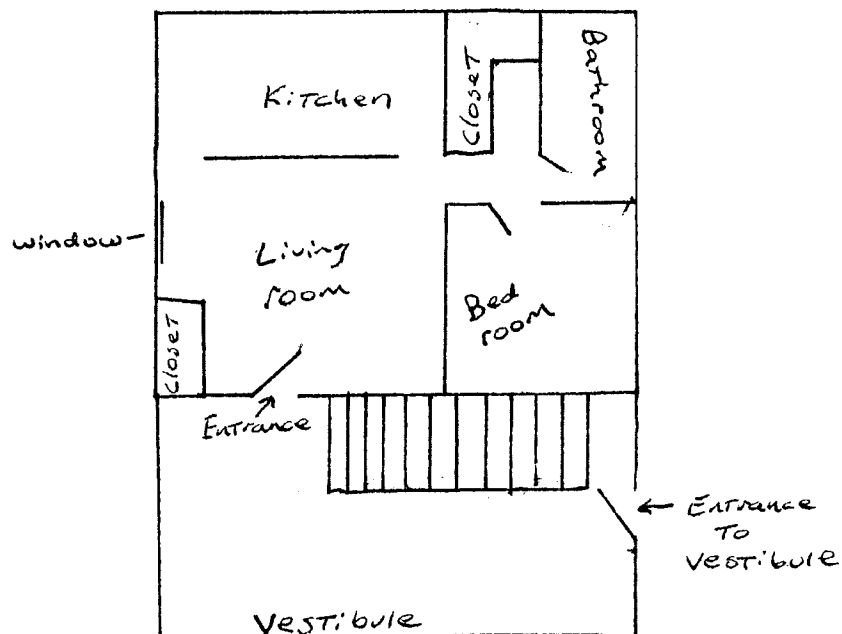
CRENSHAW HOUSING AUTHORITY  
Madison View Apartments  
Floor Plan  
Basic one Bedroom

Basic one Bedroom layout  
And entrance Vestibule  
Example: 733 Johns Dr. Apt. 11

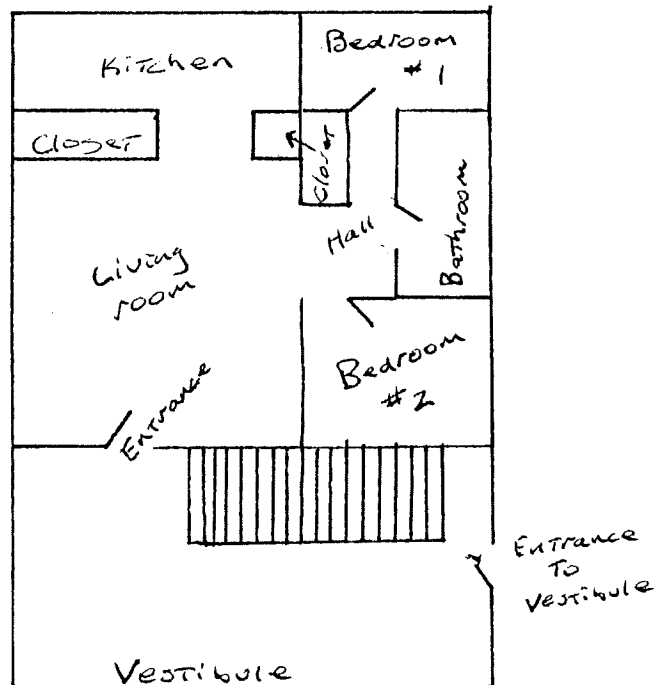
Stevens Point Housing Authority  
Madison View Apartments  
Floor Plan: Basic two (2) Bedroom

Basic Two Bedroom Layout  
and Entrance Vestibule  
Example: 733 Johns Dr. Apt. 8

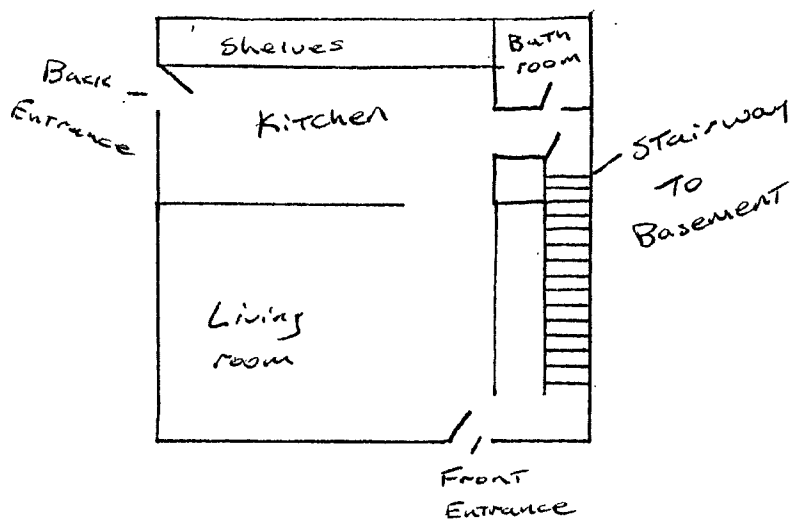
First Floor Plan

Stevens Point Housing Authority  
 Madison View Apartments  
 Floor Plan  
 Basic Three Bedroom, Three story

Example:  
 741 Johns Dr. Apt # 1
